## **FLOWER GARDEN BANKS NATIONAL MARINE SANCTUARY DRAFT - POST HURRICANE IKE QUICK LOOK CRUISE REPORT**

OCTOBER 17, 2008

Prepared by Emma L. Hickerson

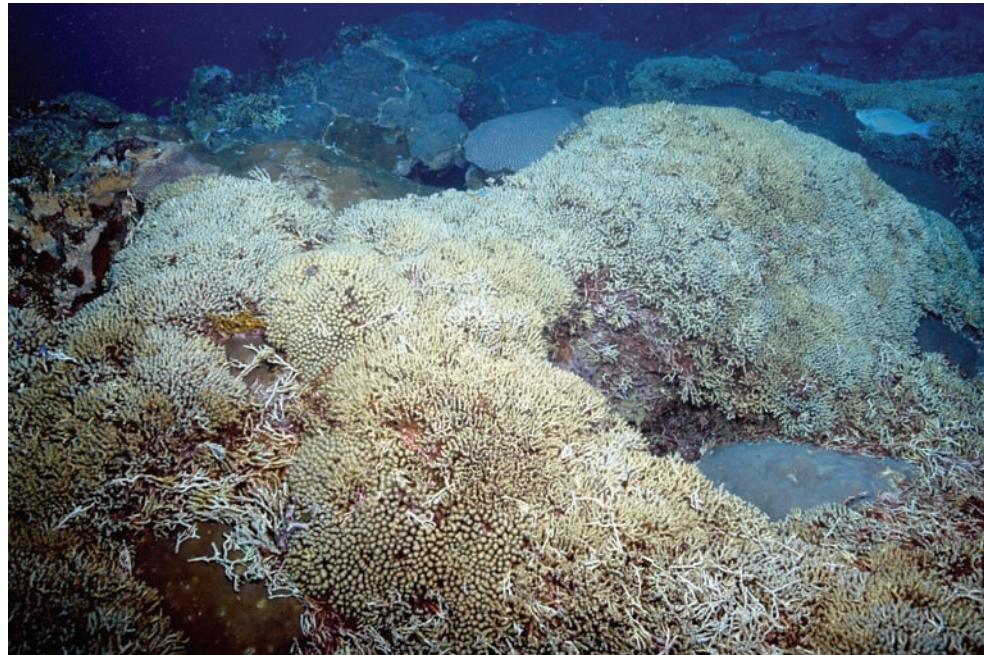
Figure 8. *For comparison, Madracis field prior to both Hurricanes Rita and Ike (August 2005). Photo credit: FGBNMS/G.P. Schmahl*

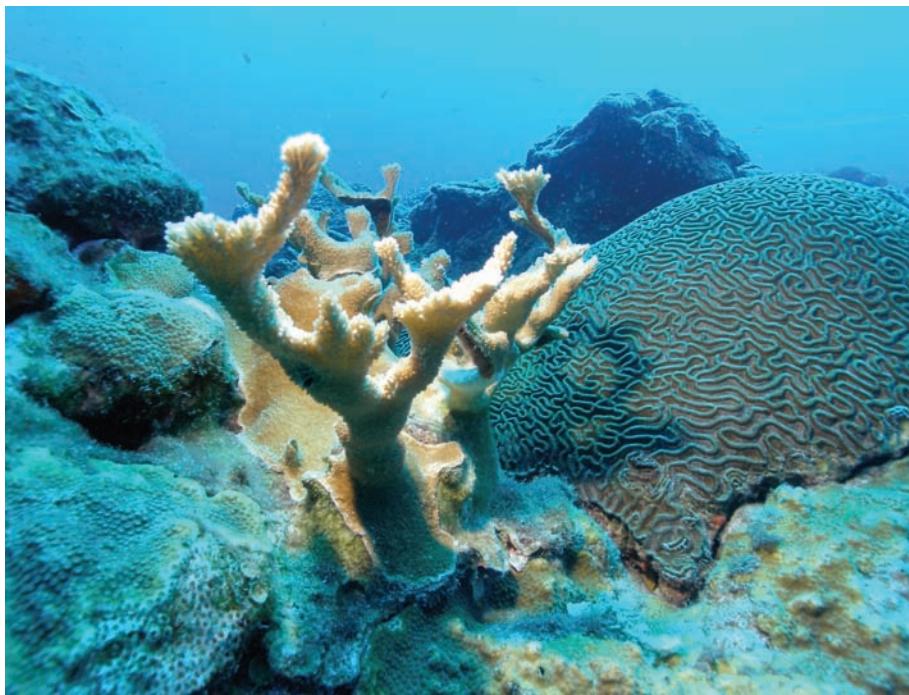
Figure 11. *For comparison, north side of the EFGB Acropora in June 2006.*

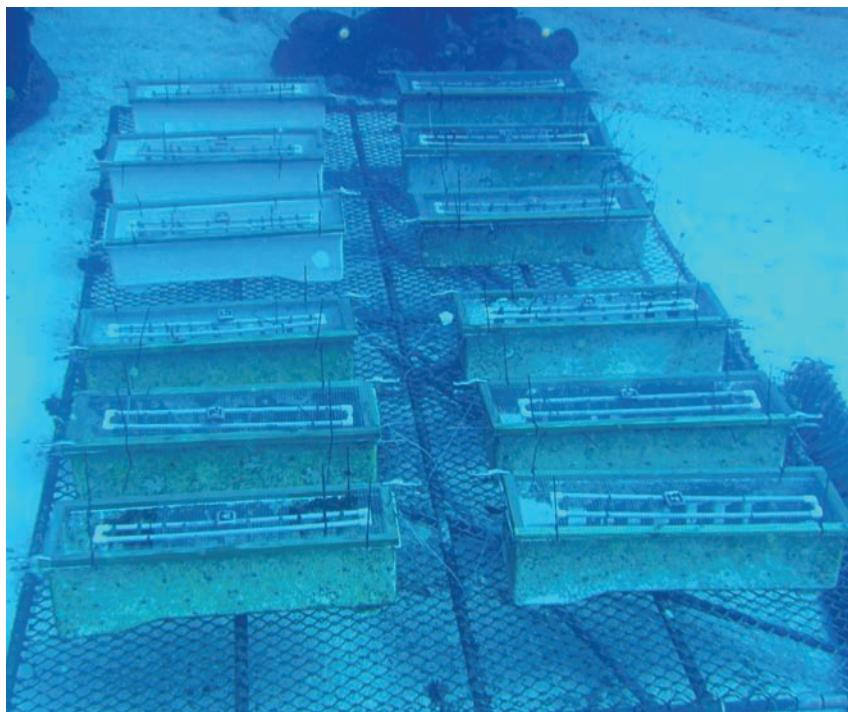
Figure 15. *Recruitment rack as it was at the end of August 2008.*

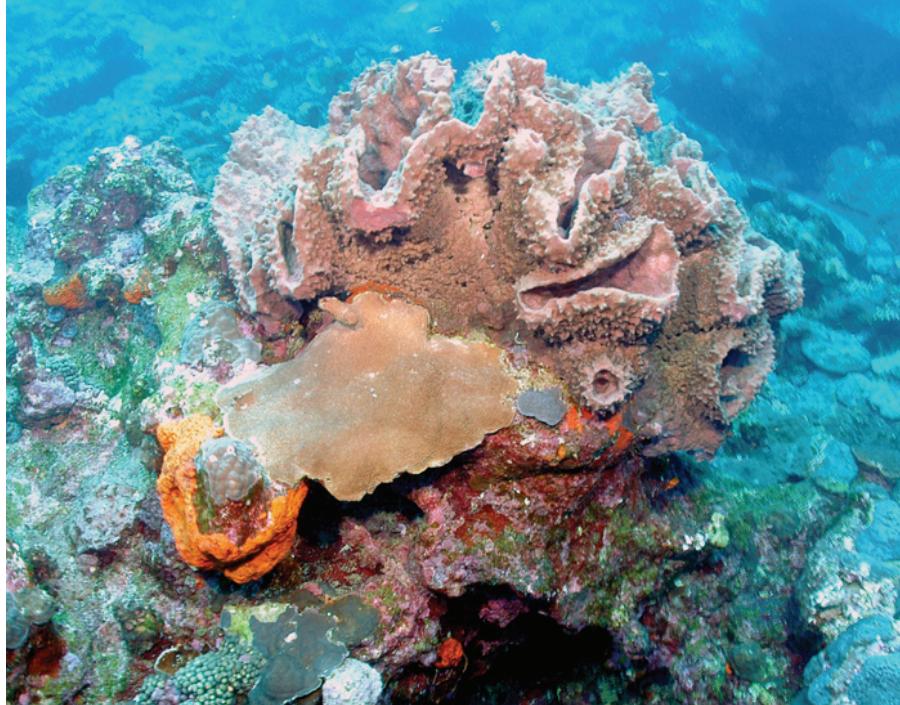
Figure 22. A similar shot of the WFGB Acropora and sponge taken in February 2005 – pre-Rita.

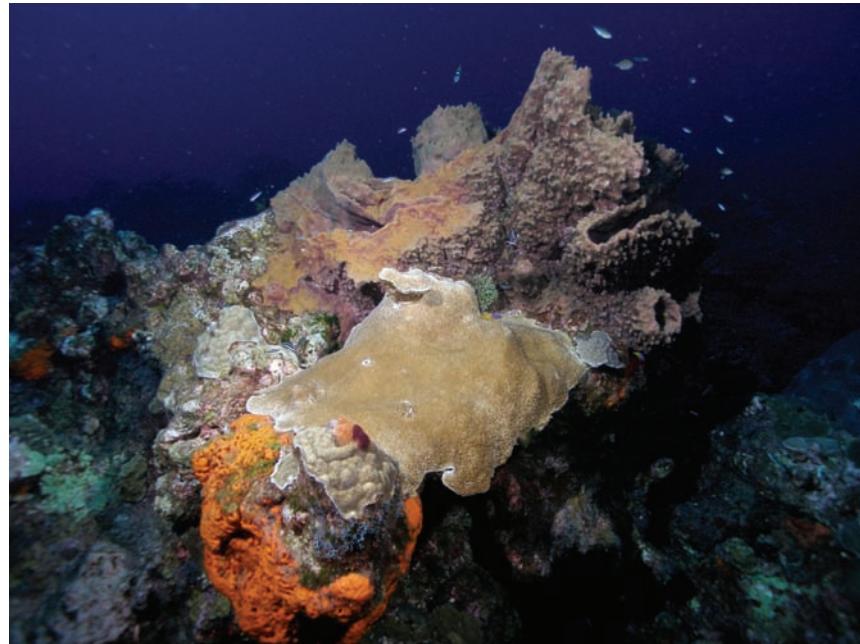
Figure 23. Same colony of WFGB Acropora in June 2006, nine months after the passage of Hurricane Rita. The barrels on the left side of the giant barrel sponge (*Xestospongia muta*) were sheared off.

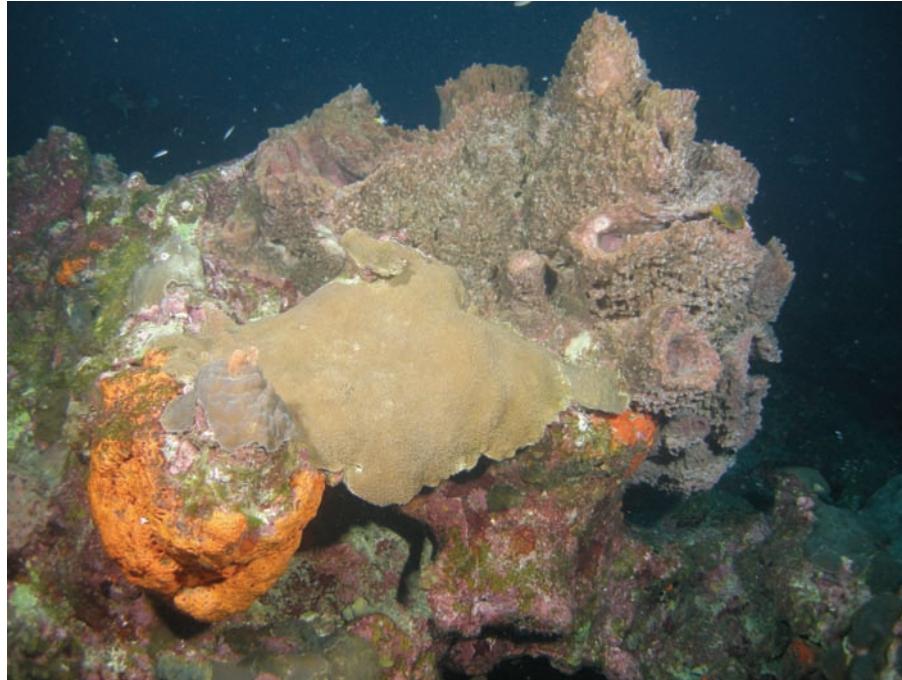
Figure 24. *A similar shot of the WFGB Acropora and sponge taken in July 2008. You can see the barrels on the upper left side are recovering nicely after impacts caused by Hurricane Rita in 2005.*
